# ANNUAL REPORT FOR 2006

**Wastewater Treatment Mitigation Site**

**New Hanover County**

**TIP No. U-0092 A/B**

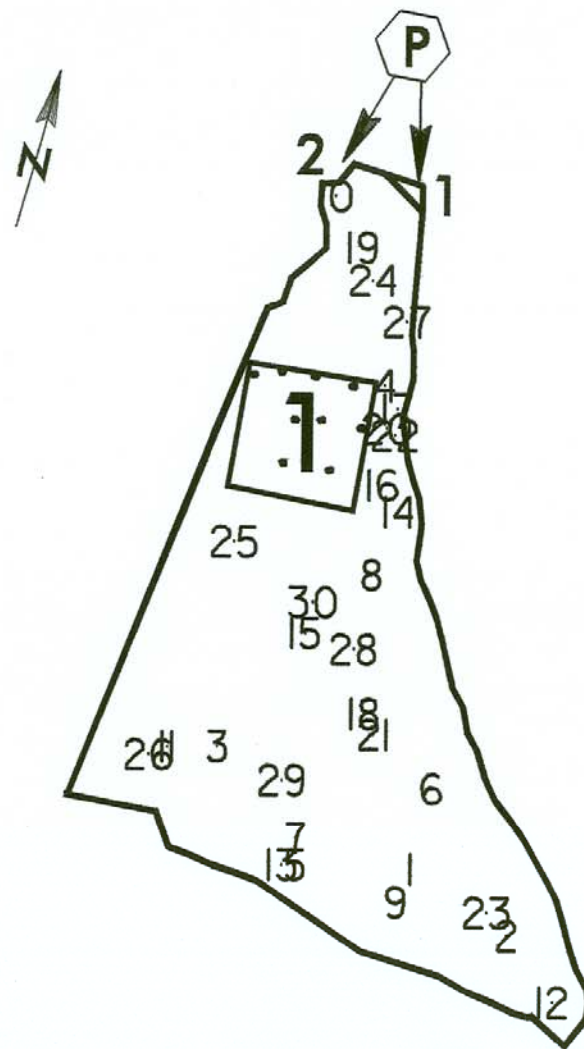
2006 Photo, Plot, and Random Point Locations

Approximately 0.71 acres of this site involved marsh grass plantings. There were 30 random plots established throughout the planting area. These plots were located with GPS. The percent frequency has been declining since year one due to the cattails out-competing the target species. The overall comparison of the percent frequency and the scale value for the marsh grass area is on track for the third year of monitoring.
